3 OHIO RIVER BASIN
HOWELLS RUN, CAMBRIA COUNTY

2 HOWELLS RUN DAM
CID Number PA 434

4 PHASE I INSPECTION REPORT
1 NATIONAL DAM INSPECTION PROGRAM,

D'APPOLONIA CONSULTING ENGINEERS
10 DUFF ROAD
PITTSBURGH, PA. 15235
JUNE 1978

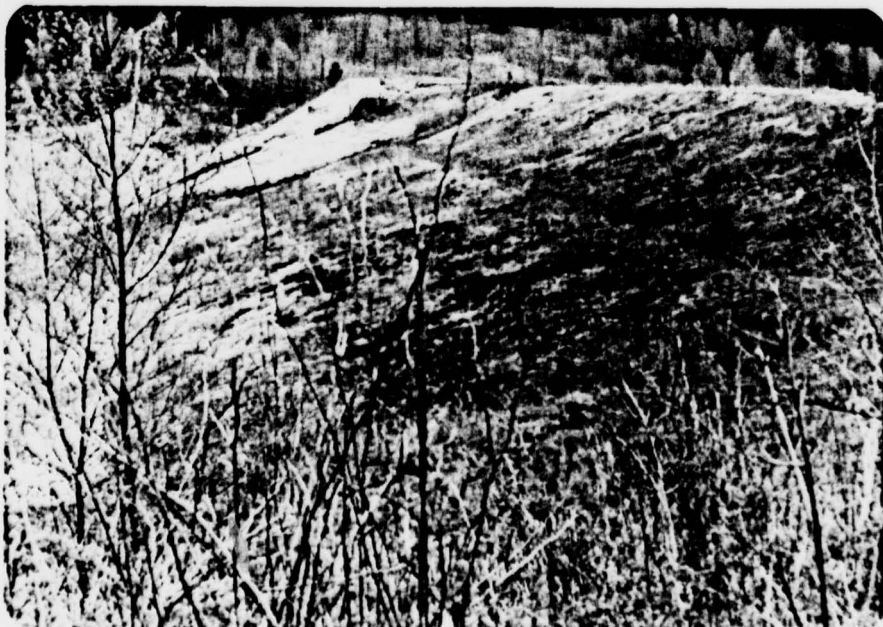
Downstream Face

4. High grass and patches of brush were found to impair the adequate inspection of the downstream face of the dam.

4.2 Maintenance of the Dam. The overall maintenance conditions of the dam appear satisfactory. However, annual mowing of the downstream face should be instituted.

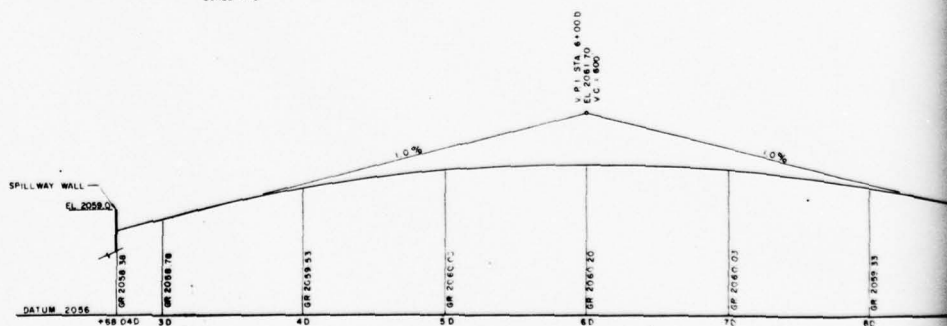
DIAGRAM OF CAMBER FOR CREST OF DAM

elevation. Review of the design drawings indicates that this condition was the result of camber built into the crest of the dam (Plate 1).

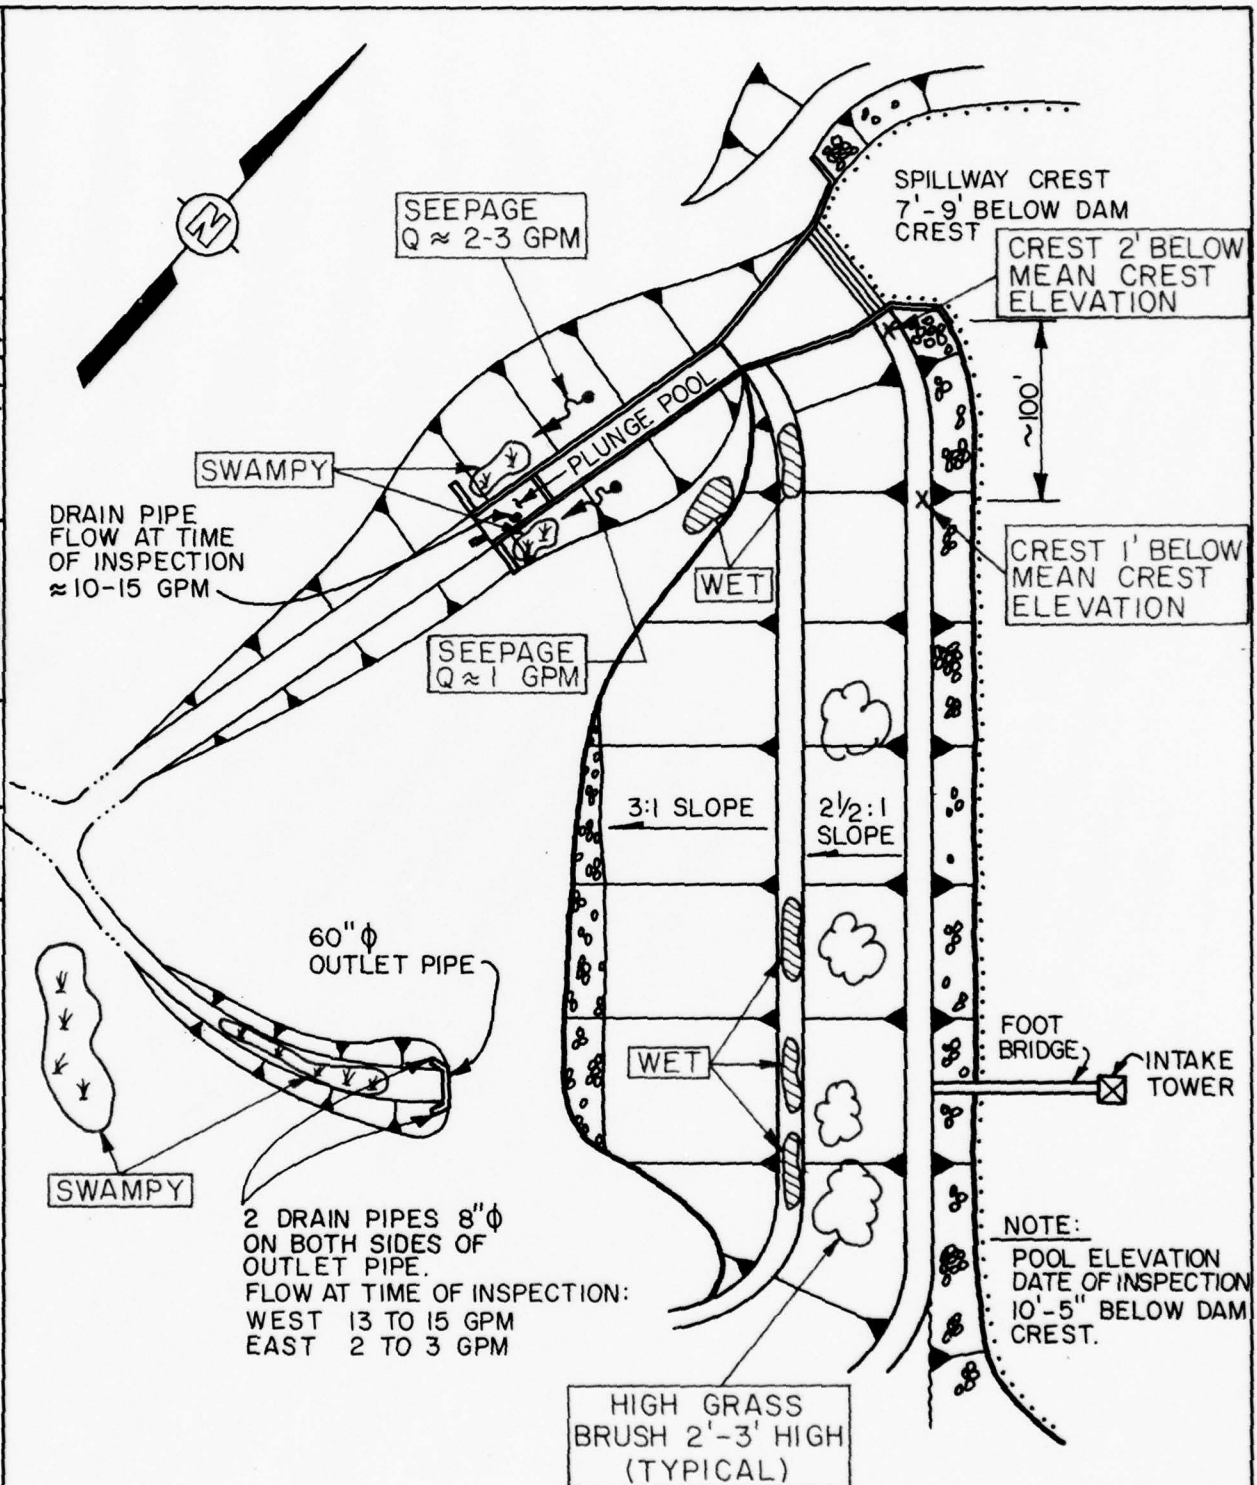
VISUAL EXAMINATION OF	OBSERVATIONS	REMARKS OR RECOMMENDATIONS
JUNCTION OF EMBANKMENT AND ABUTMENT, SPILLWAY AND DAM	CONCENTRATED SEEP ON EACH SIDE OF SPILLWAY GUTE.	SEE PLATE 5
ANY NOTICEABLE SEEPAGE	SOME WET AREAS ON DOWNSTREAM SLOPE BENCH.	SEE PLATE -5
STAFF GAGE AND RECORDER	NONE FOUND.	
DRAINS	THREE DRAINS LOCATED ONE DISCHARGING INTO THE SPILLWAY PLUNGE POOL. TWO DRAINS ON BOTH SIDS OF DRAIN PIPE	SEE PLATE -5.

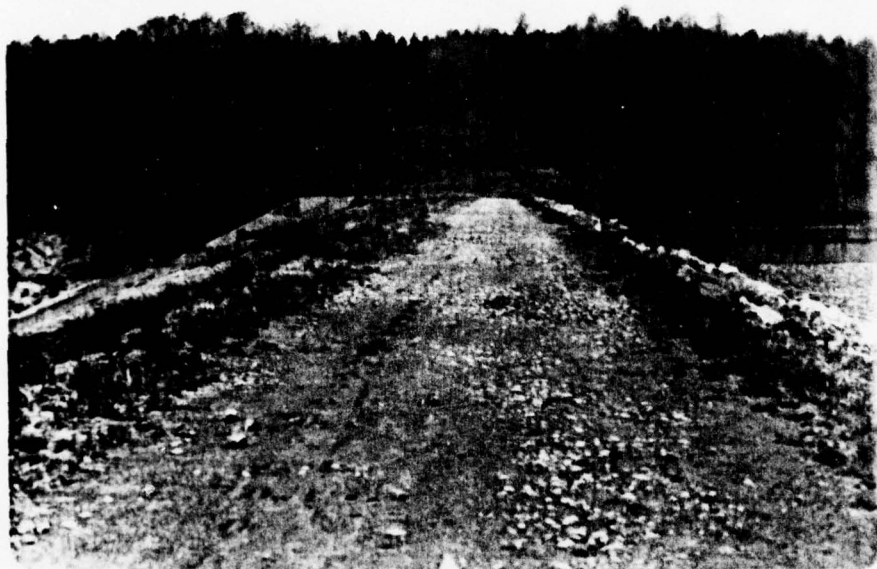
Photograph No. 1
Dam crest.

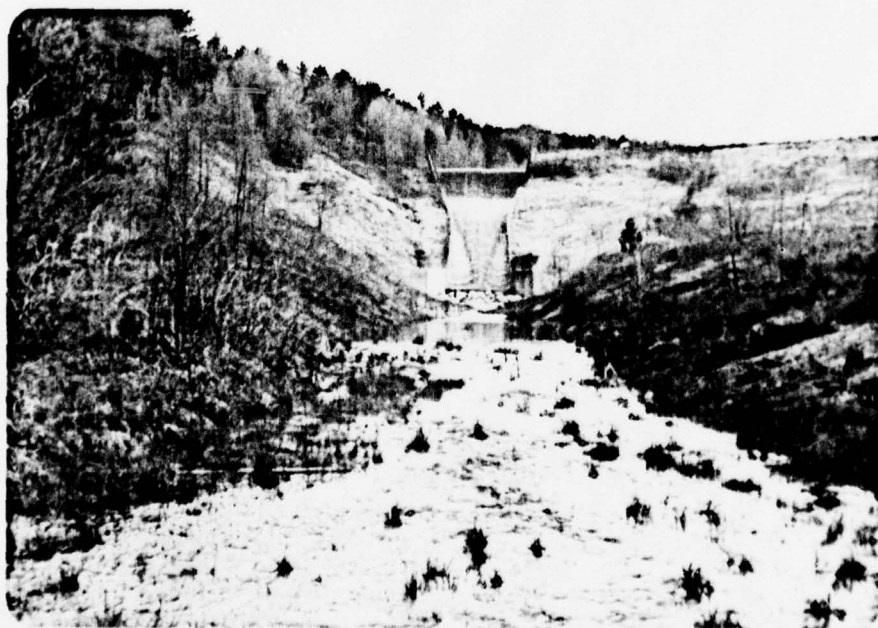
Photograph No. 2
Right abutment, spillway, and discharge channel.

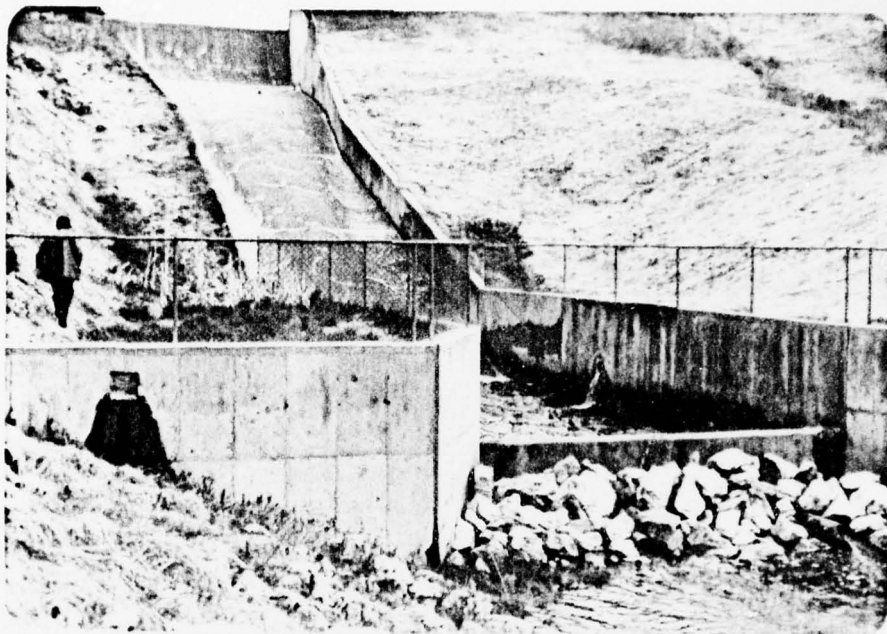
Photograph No. 3

c. Appurtenant Structures. The spillway crests and plunge pools were examined for deterioration of the concrete or other signs of distress and obstructions that would limit flow. These structures were found to be in good condition and performing satisfactorily. As can be determined from the downstream end, the condition of the drainpipe is considered good.

Plunge pool.

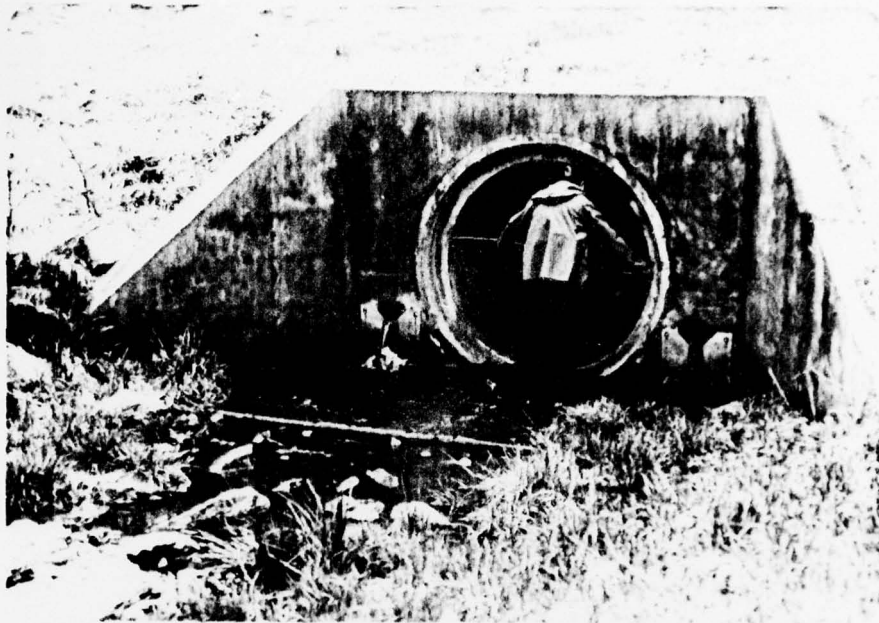
Operation of the outlet pipe gate was not observed. The owner reports that the gate has never been operated and therefore its operational condition is questionable.

4.3 Maintenance of Operating Facilities. The operation of the outlet pipe sluice gate was not observed. Borough personnel reported that the gate has never been operated and the functional condition of the gate was questionable.

Photograph No. 5
Outlet pipe and toe drainpipes.

1. The owner should take immediate action to evaluate the operational condition of the drainpipe sluice gate.
2. The downstream face of the dam should be cleared of high grass and brush to permit adequate inspection of the face of the dam and annual mowing of the dam face should be instituted.
3. It is recommended that the owner monitor the uncontrolled seeps on each side of the spillway channel and take necessary remedial measures if the seeps are found to be increasing.
4. The owner should be advised that the dam and appurtenant structures should be inspected regularly and any unusual conditions should be reported to the appropriate authorities.

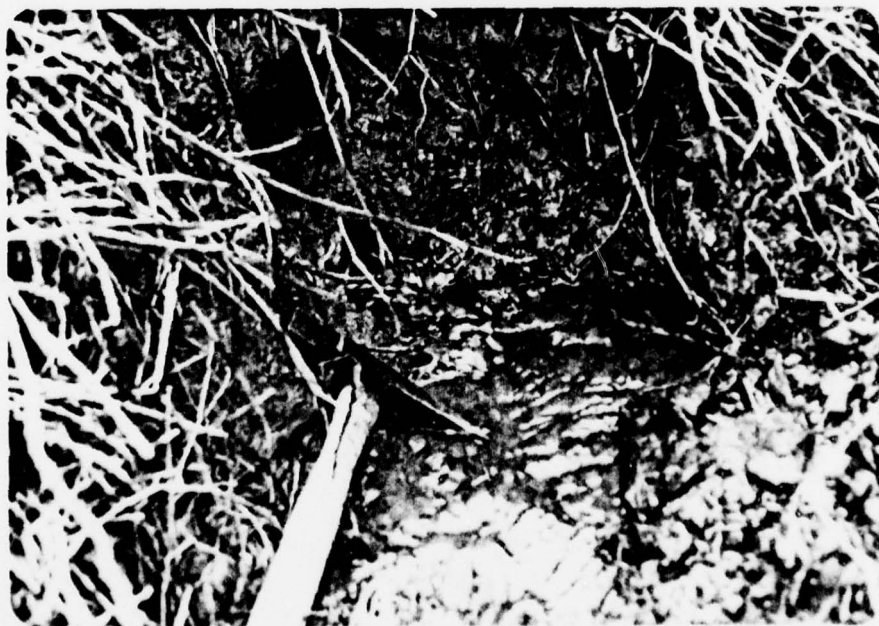
1. Two concentrated seeps were observed on the natural ground located on each side of the spillway chute. The flow from the right side seepage was estimated to be two to three gallons per minute (gpm). The left side seepage was estimated to be one gpm. These seeps are not considered to be affecting the overall performance of the embankment, however, they should be closely observed to assure that they are not increasing.
2. Various wet areas were observed along the bench on the downstream slope of the dam. No perceivable amount of water was discharging from these areas.
3. The crest elevation along a 100-foot section immediately adjacent to the spillway was found to be one to two feet below the crest

3.2 Evaluation. In general, the condition of the dam is considered to be good. Review of PennDER correspondence files indicates that the seepage condition along the spillway chute was previously noted (1964) and the owner was advised to evaluate the condition and to undertake necessary repair measures. The seepage problem was evaluated by F. T. Kitlinski and Associates, Consulting Foundation Engineers, of Harrisburg, Pennsylvania, and was found to be not serious. Subsequent flow measurements taken indicated that the seepage was gradually decreasing.

The present condition of this seepage problem is considered not serious.

Photograph No. 6
Seepage at the right abutment.

It is recommended that the owner monitor the uncontrolled seeps on each side of the spillway channel and take necessary remedial measures if seeps are found to be increasing.
